VOLUME 9 ISSUE 9 SEPTEMBER 2006

Doing The Sombrero Dance In Your '63-'78 Corvette

Ever heard or felt a “sombbrero bushing” fail? No, we’re not talking about a Mexican hat dance. Sombrero bushings are the two bushings that isolate the ‘63-’78 differential crossmember from the frame.

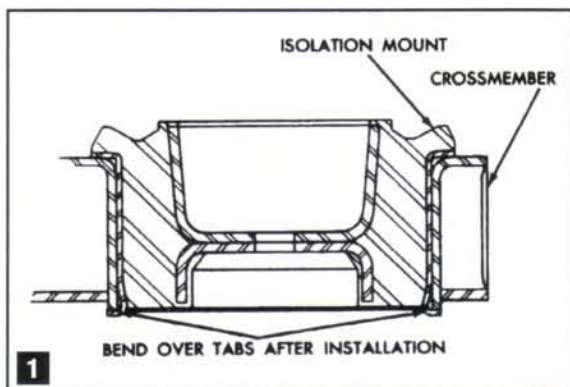
1 Cross section of the “sombbrero” bushing installed in the crossmember; the flange at the top of the bushing’s outer shell had rusted through and sheared off.

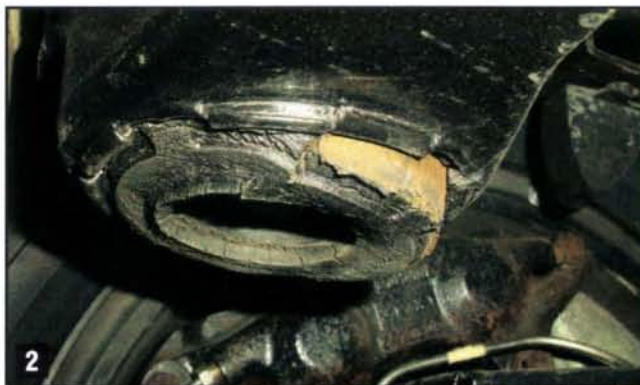
What Happened: Close inspection on the lift showed that the “sombbrero” bushing had failed where the driver’s side of the differential crossmember attaches to the frame. The upper flange on the outer shell of the bushing

had sheared off, which allowed the crossmember to slide up and ground out solid against the frame. The bang I heard and felt was the sound of the top of the crossmember hitting the frame when the bushing failed.

2 Photo of the failed bushing showing how the crossmember moved upward against the frame when the flange at the top front of the bushing sheared off. This was the “BANG” I heard and felt when it failed.

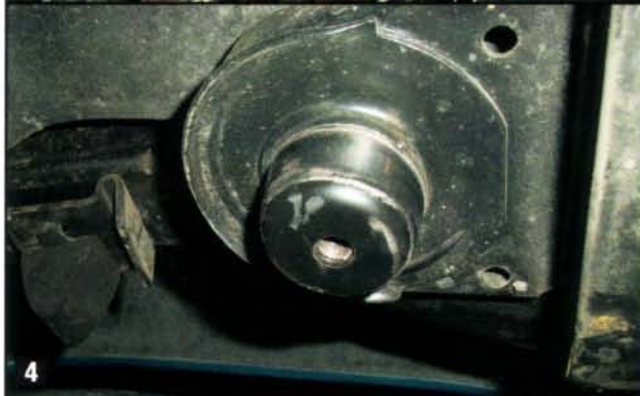
4 One of the sombrero-shaped formations welded to the frame; the vertical bushing through-bolt engages the weld-nut in the center.

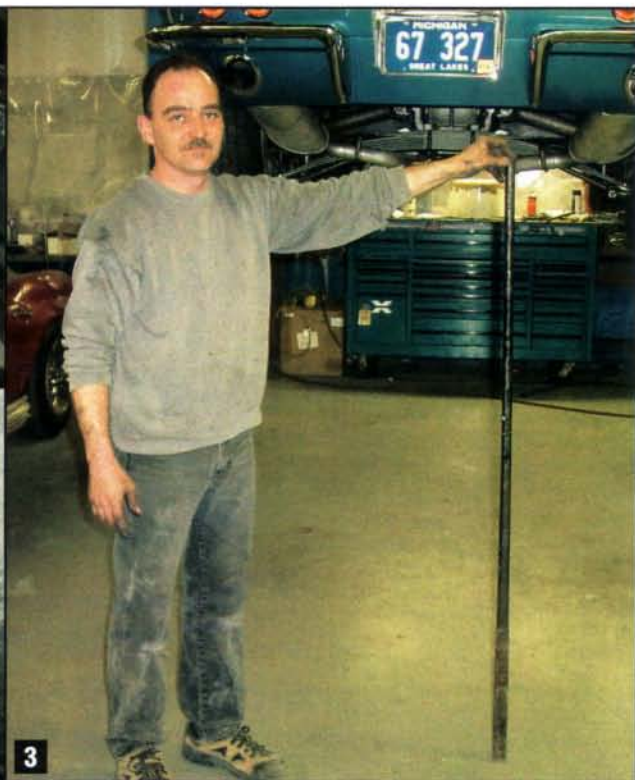
3 Rick Parks with his “super pry bar” that makes quick work of popping the bushings free of the sombrero formations on the frame.

With the diff supported on a transmission jack under the spring plate, he removed the sombrero bushing bolt on each side and used his 5½-foot “super pry bar” to pop the bushings loose from the “sombbrero” formations on the frame. Then he lowered the diff on the jack a few inches, and went in from the front side of the crossmember with a flat ratchet air wrench and special socket, and removed the four bolts that attach the diff cover to the crossmember. With those four bolts removed, Rick lowered the diff a bit more and slid the crossmember out above it, ready to work on the bushings.

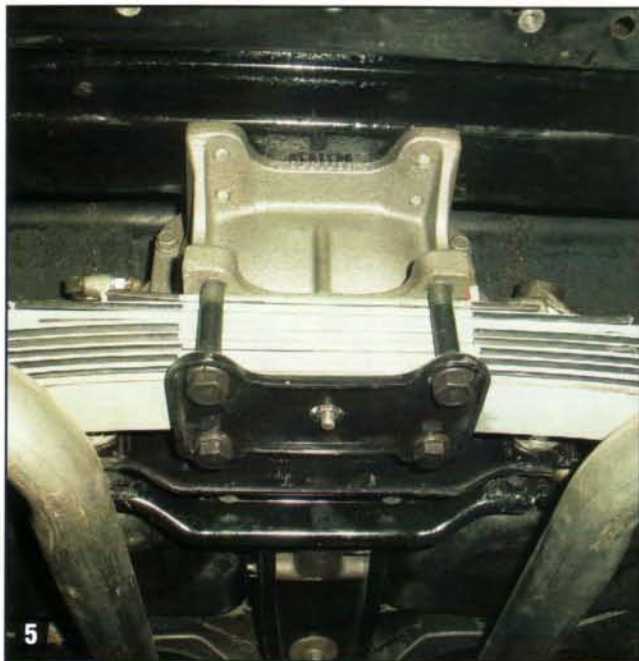
5 You can see the ends of the four bolts at the top that secure the diff rear cover to the bushing crossmember. Rick's method permits removing them to pull the crossmember without complete disassembly of the rear suspension.

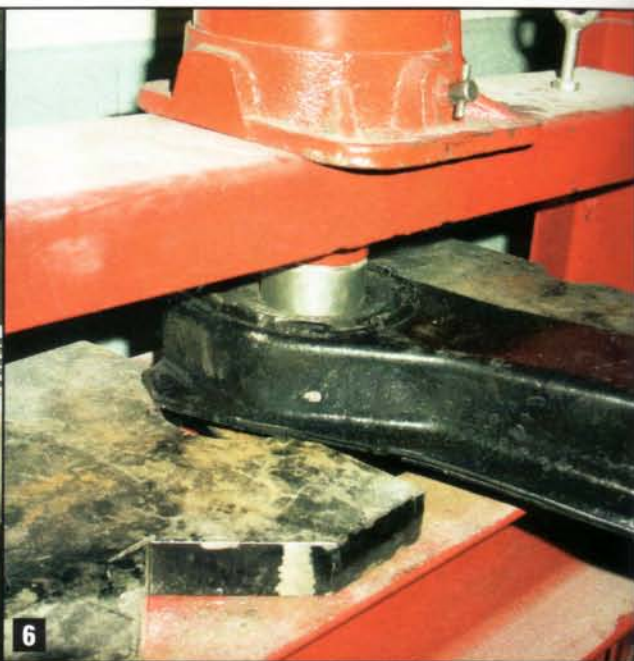
6 Setup for pressing the old bushing center sleeve and rubber isolator out of the bushing's outer shell; removal of the outer shell is a bench job.

Rick set the crossmember up on plates in the hydraulic press, and used a punch slightly smaller in diameter than the outer sleeve of the bushing to press out the center sleeve and rubber isolator as a unit, shearing the rubber bond to the outer sleeve at the same time. This leaves just the outer sleeve to deal with.

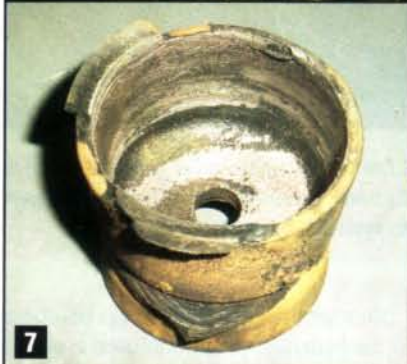
7 This is a top view of the center sleeve after pressing it out of the bushing; the rubber isolator came with it,

but is shredded in the process.

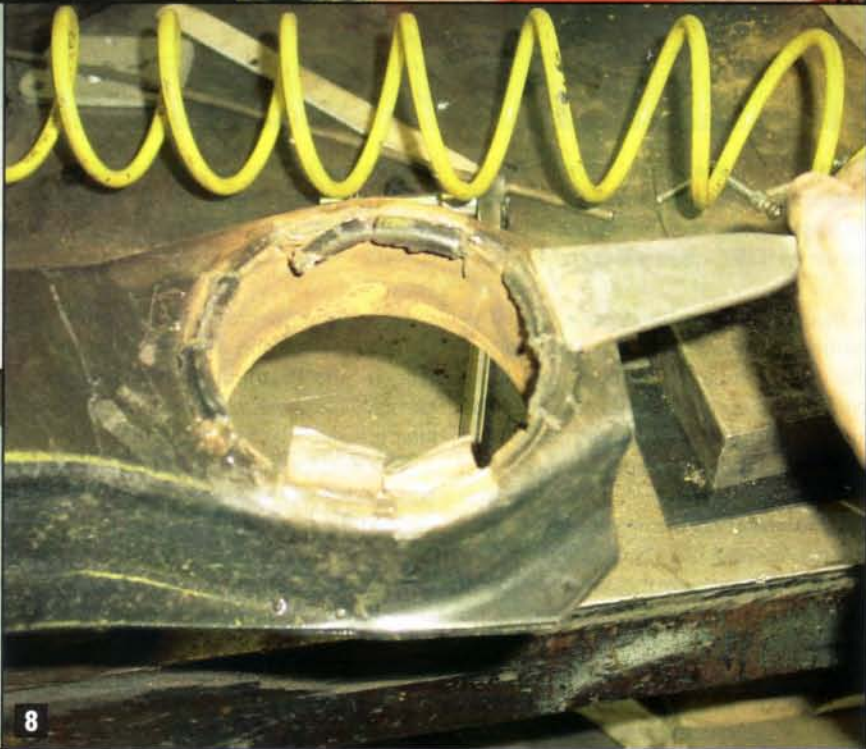
8 With the guts pressed out, the bushing's outer sleeve tabs are bent up and the sleeve is cut out of the crossmember with an air chisel.

On the bench, Rick used an air chisel to open the bent-over retaining tabs on the bottom of the outer sleeves and cut them out of the crossmember and then worked the holes in the crossmember to make sure they were round, smooth and free of burrs to ease installation of the new bushings.

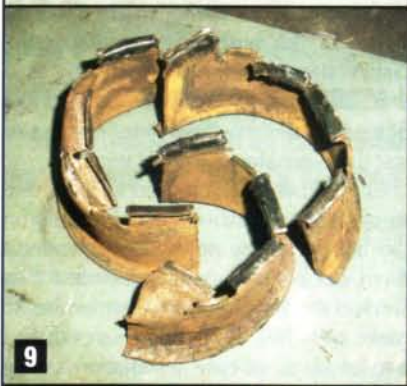
9 Pieces of the outer sleeve after being cut out of the crossmember.

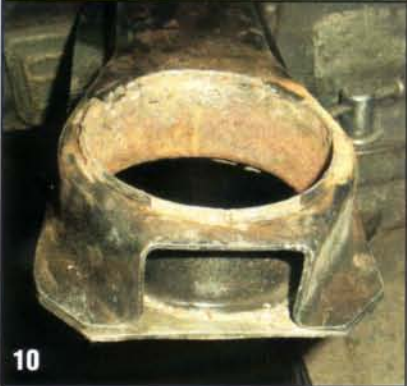
10 After chiseling out the sleeve, the openings in the crossmember are worked to remove any burrs that would complicate installation of the new bushings.

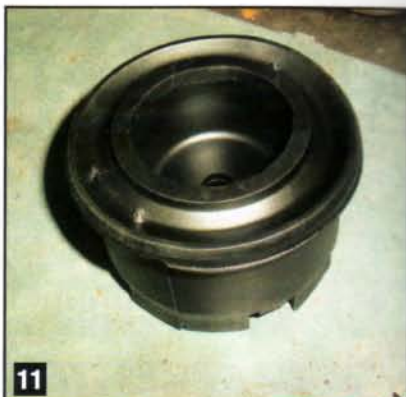
11 Top view of the new bushing; the "well" in the center sleeve is the part that mates metal-to-metal with the sombrero formation on the frame when the through-bolt is torqued. Note the flange at the top, which was the failure point on the old bushing, and the "tabs" at the bottom, which will be bent over after pressing the bushing into the crossmember.

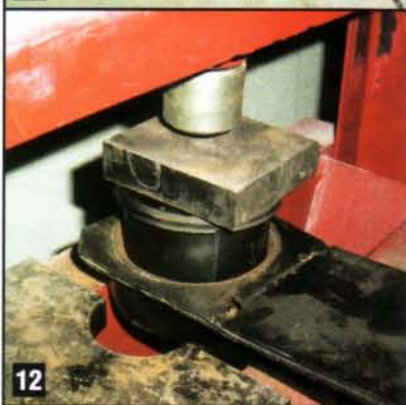
12 Press setup for installing the new bushings. Note the steel plate used on top of the bushing to ensure even pressure and a straight-in assembly. With the new bushing fully seated in the crossmember, it will go to the bench to bend and seat the tabs that retain it at the bottom.

New Bushing Installation: The crossmember went back in the press, with the new bushing squarely positioned in the opening, and a square plate was used to press the bushings all the way into the crossmember, with their upper flanges firmly seated against the surface. A ball peen hammer was used to bend over the retaining tabs on the bottom of the bushings and seat them flat on the crossmember. These tabs serve no stressed function, as

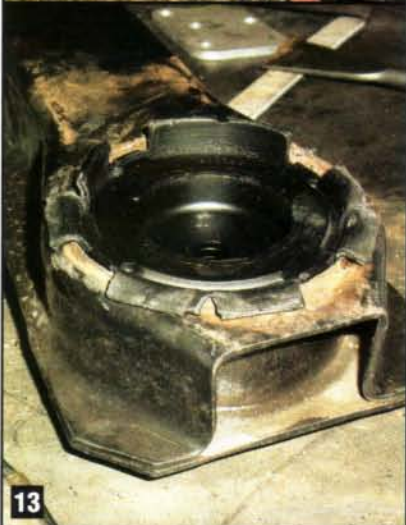
13 The crossmember inverted on the bench, showing the protruding tabs that must be bent over to retain the bushing. A stout hammer is used to bend over the retaining tabs against the bottom of the crossmember — half are done in this photo.

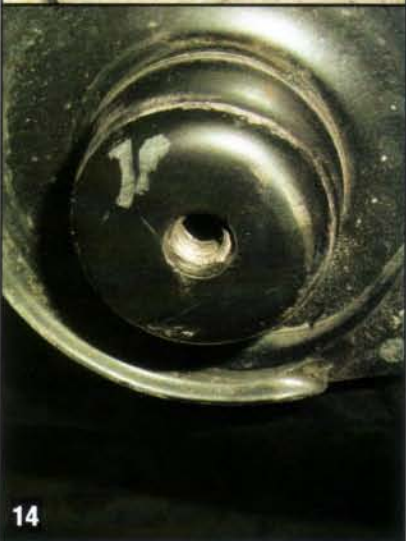
14 The sombrero formation is cleaned up and ready for crossmember installation. Don't cross-thread the weld-nut or knock it loose — the body has to come off the frame to repair it.

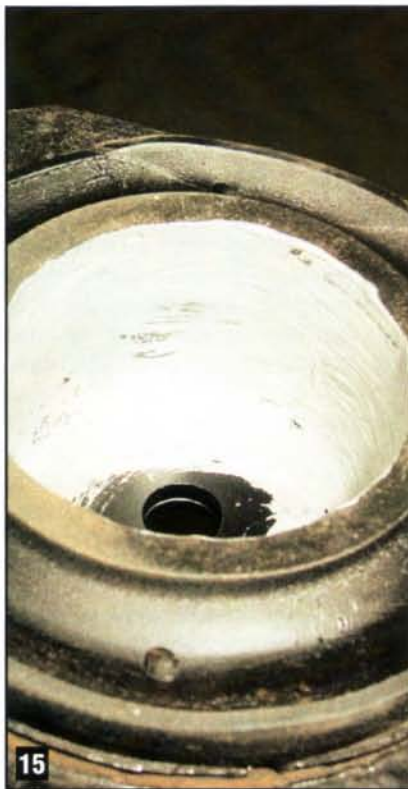
15 Anti-seize applied to the top of the bushing's steel inner sleeve prior to crossmember installation, simplifies seating to the sombrero formation on the frame and makes future disassembly much easier.

The surfaces on the sombrero formations on the frame were cleaned up, and the mating female steel formations in the top of the bushings were coated with anti-seize to ease installation (and disassembly if required in the future for other major

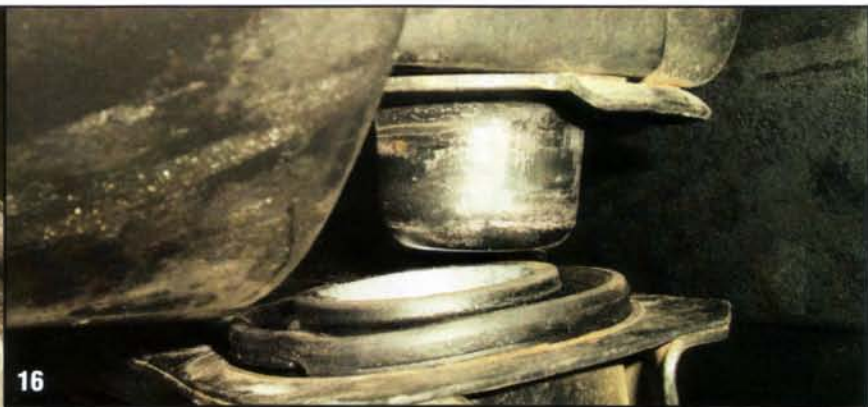
16 Aligning the crossmember to the sombrero formation on the frame prior to raising the differential with the transmission jack.

service). The crossmember was slid into position above the diff, and the four diff attaching bolts were installed using the same air tool and socket used earlier to remove them. Then the transmission jack under the diff was raised, the bushings were centered on the sombrero formations on the frame, and a spinner jackstand was used on each side in addition to the transmission jack to press the crossmember up in place and seat

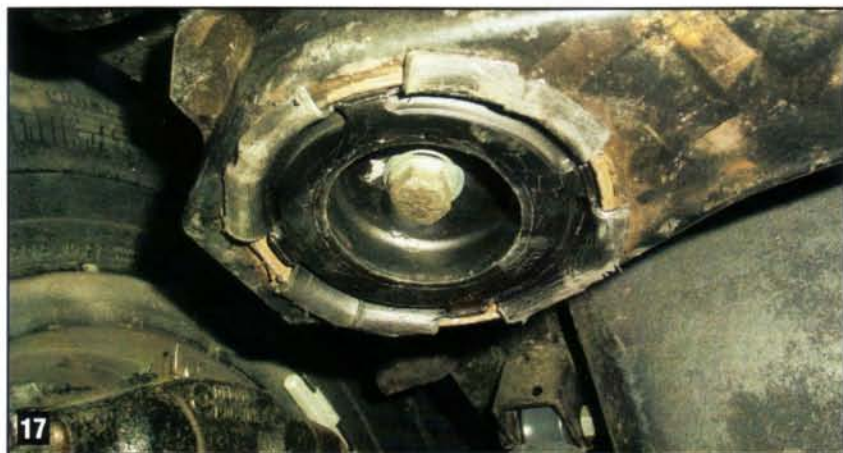
17 The crossmember and new bushings back in place, through-bolts torqued, ready for another 40 years and 90,000 miles.

the bushings on the sombreros. The single attaching bolt was installed through each bushing and torqued, and the jackstand and transmission jack were removed.
